**Fourth Five-Year Review Report for  
Advanced Micro Devices 901/902 & TRW Microwave  
Superfund Sites  
Includes the "Companies' Offsite Operable Unit"  
Santa Clara County, California**

U.S. Army Corps of Engineers, Seattle District

U.S. Environmental Protection Agency, Region 9

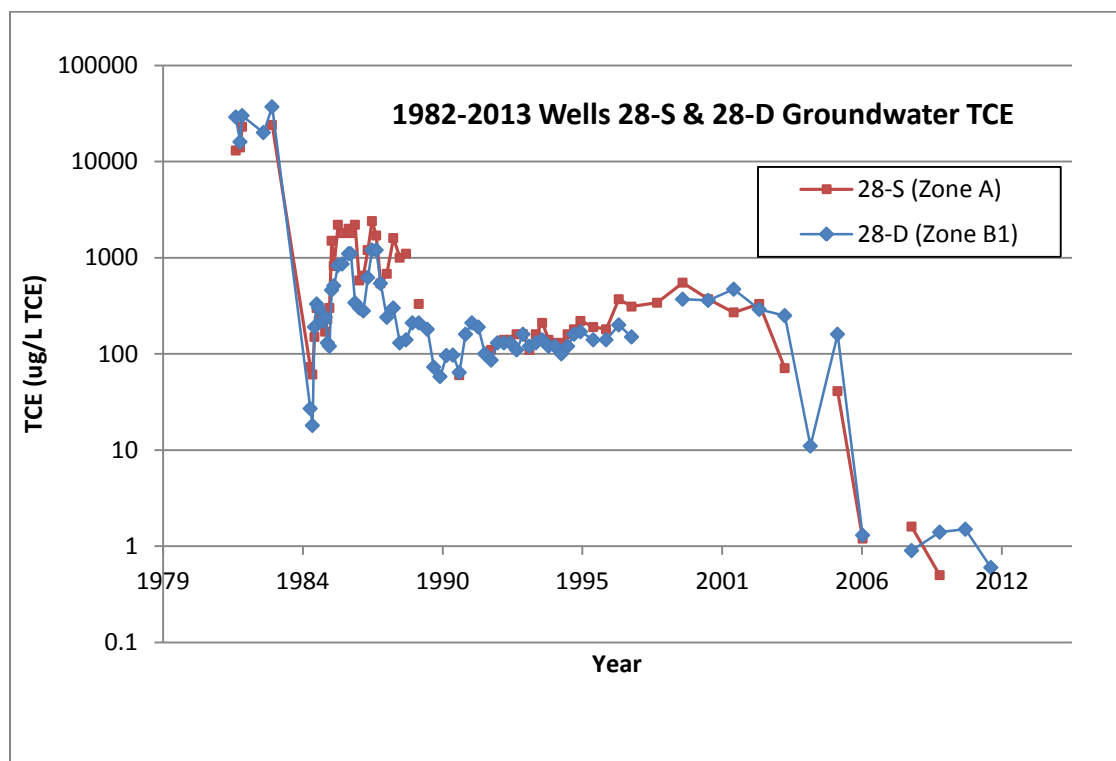
Figure 11. AMD TCE concentrations in wells 28-S and 28-D, 1982 – 2013

Overall, groundwater TCE data from source area well cluster 28-S/D for the time period 1982-2013 clearly shows that remedial efforts have greatly reduced COC concentrations in the AMD source area since implementation of the remedy began (Figure 11). However, COC concentrations remain elevated above cleanup levels at the site. Groundwater trends in the ISB treatment zone and the areas up- and down-gradient from the ISB are each discussed in more detail below. October 2013 iso-concentration contours and individual well concentration data for TCE, one of the primary COCs at the site, are presented in Figure 12, Figure 13, and Figure 14 for the first three water-bearing zones (A, B1, and B2). Groundwater concentration plots of TCE versus time for each area are presented in Figures 15 through 19. Additional information supporting the data review is provided in Appendix F.

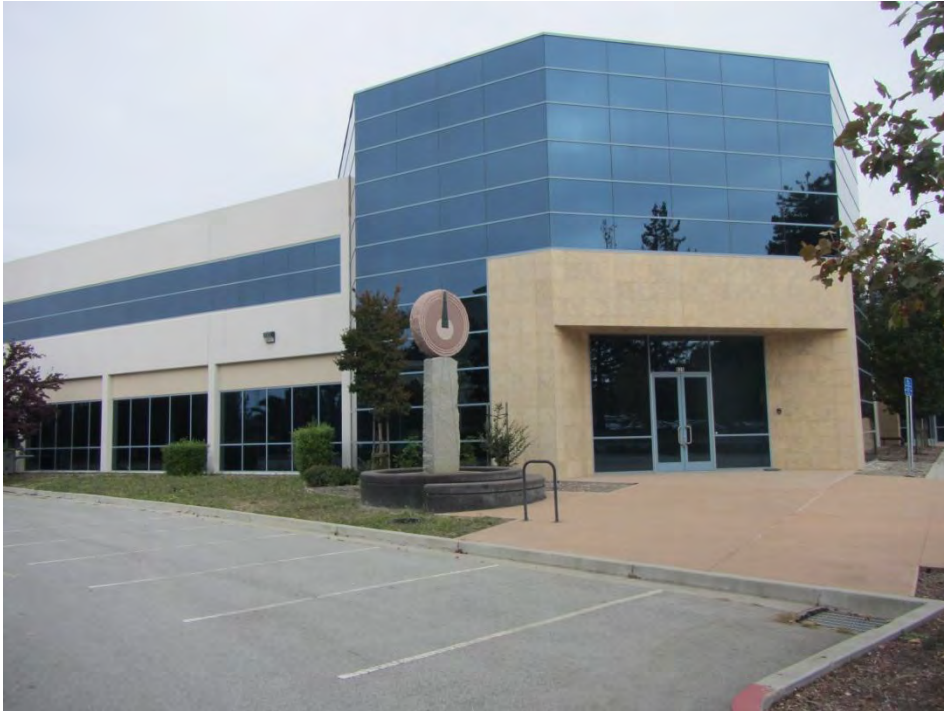
TRW Photo 1. TRW Microwave Building (unoccupied)

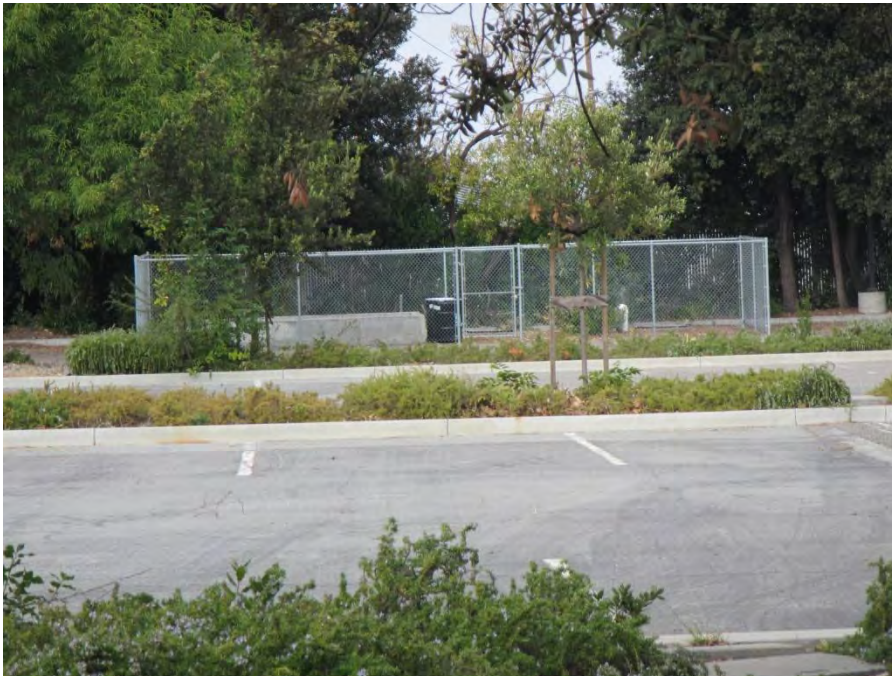
TRW Photo 4. Location of former extraction and treatment system (components have been removed).

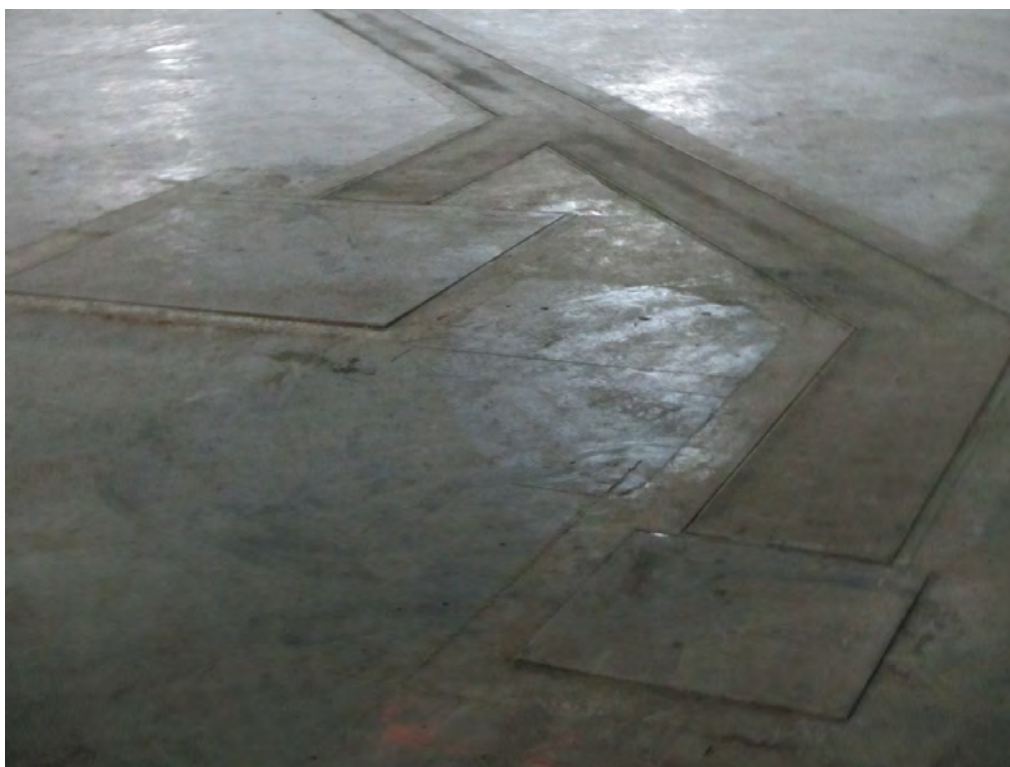
TRW Photo 10. Source zone (inside building).
